## Survey of the Giant Gippsland Earthworm, *Megascolides australis* in areas potentially affected by a realignment of the South Gippsland Highway – Bena to Korumburra

Van Praagh, B.D., and Hinkley, S.D. 2002. Survey of the Giant Gippsland Earthworm, *Megascolides australis*, in areas potentially affected by a realignment of the South Gippsland Highway – Bena to Korumburra. *Museum Victoria Science Reports* 3: 1–5.

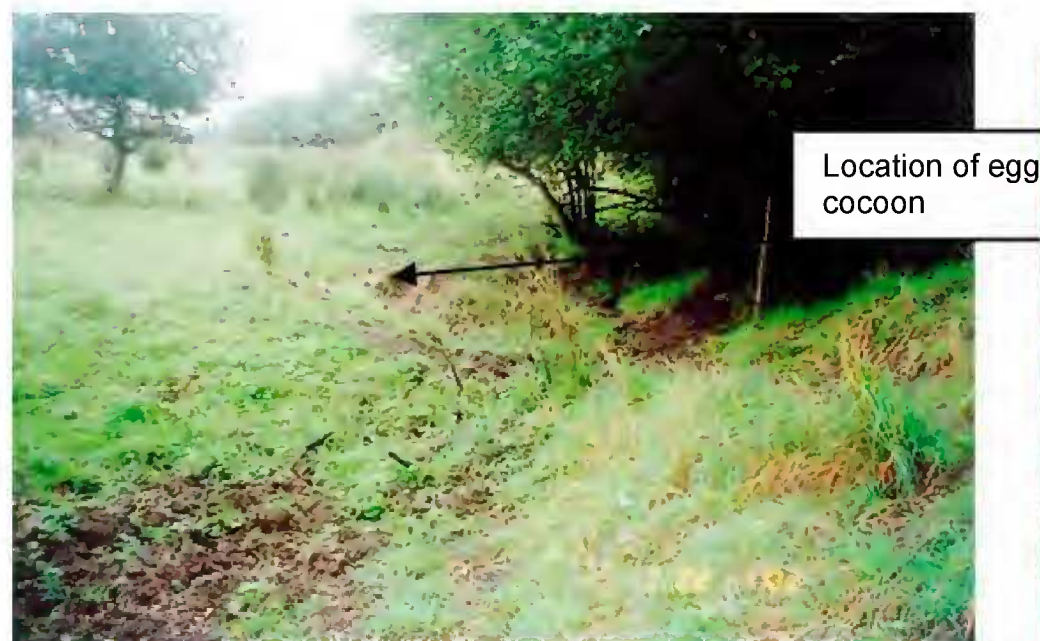
were located at 8 sites within this area (Table 1 - sites 1a to 1h). Egg cocoons were found at three of these sites (1b, 1c and 1g) and one juvenile earthworm was found at another (1d). Gurgles were heard at another 3 of the 8 sites. All of the sites except one, showed evidence that worms currently occupied them. This area consisted of pasture and scattered fruit trees (Plate 1a, b).

Plate 1a. Location of a Giant Gippsland Earthworm egg cocoon – site 1b
